This Service Bulletin revises SBRTC-2020-4, Revision 0, dated 27.07.2020.

A. SUBJECT:

Inspection of gap between the elevator root hinge assembly and the vertical stabilizer.

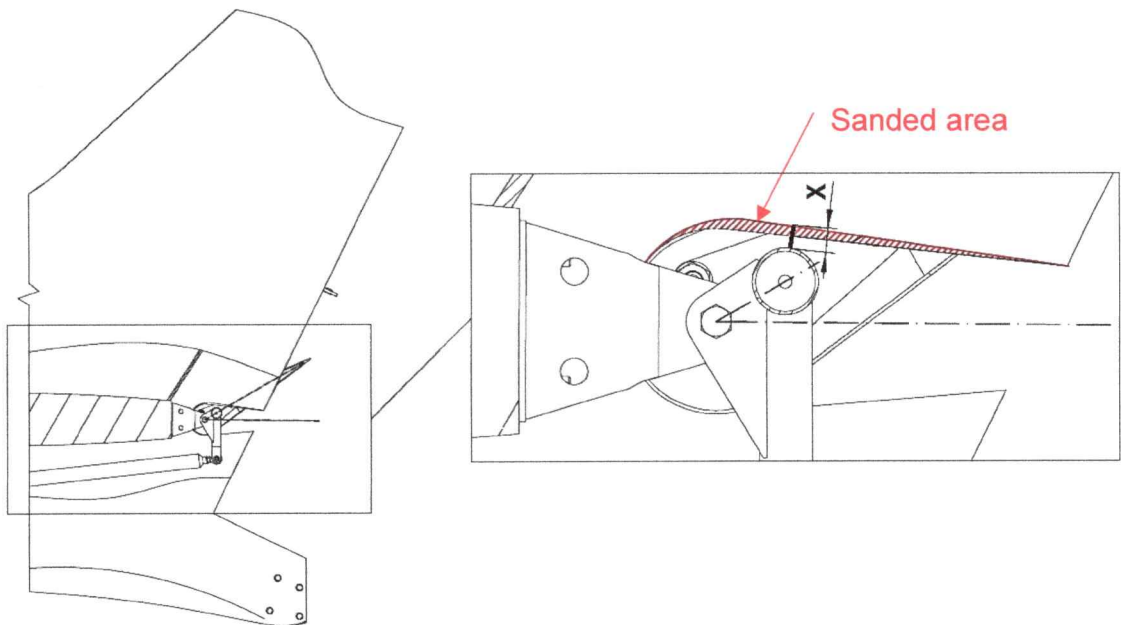
Fig. 1

In operation it was observed that the root hinge assembly may come into contact with the cut-out edge of the vertical stabilizer skin at maximum up deflection of elevator. This will result in local minor damage of the skin at the contact point.

1. Set the elevator trim to full aft position (aircraft tail heavy) and fix the control stick at the rear stop (elevator deflection 30° up) with the help of an assistant or by other appropriate means.
2. Visually inspect the gap "X" between the elevator root hinge assembly and the upper cut-out edge of the vertical stabilizer skin (Fig. 1). The minimum gap "X" is 2 mm.

5. Sand the edge of the vertical stabilizer skin using sandpaper (grit 120) until the prescribed gap "X" is ensured (Fig. 1).
6. Clean the sanded area and remove debris.
7. Remove the protection of the elevator root hinge bearing.
8. Release the control stick from the fixed position.
9. Record the compliance with this bulletin into aircraft documentation.
