INFORMATION RECOMMENDED **MANDATORY****A. SUBJECT:**

Replacement of rubber oil hose at airplanes equipped with engine Rotax Type 914 Series.

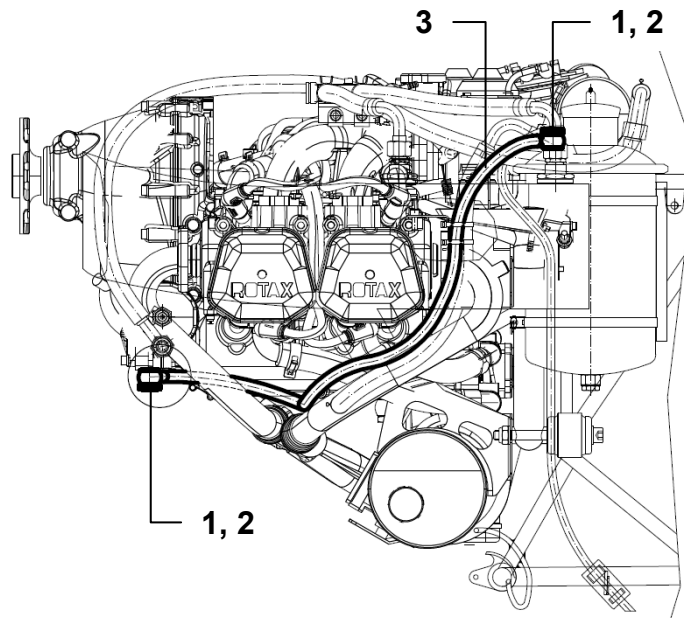
Fig. 1

Due to higher temperature in the surrounding of muffler the rubber oil hose may become brittle and crack during manipulation.

1. Remove the engine cowlings.
2. Remove banjo bolts (1), gasket rings (2) and original rubber oil hose (3) connecting the oil tank and the oil pump. Attention, there may be oil in the hose.
